Computed Tomography Analysis of Fastrac Composite Thrust Chamber Assemblies

R. Beshears
NASA MSFC
Huntsville, AL

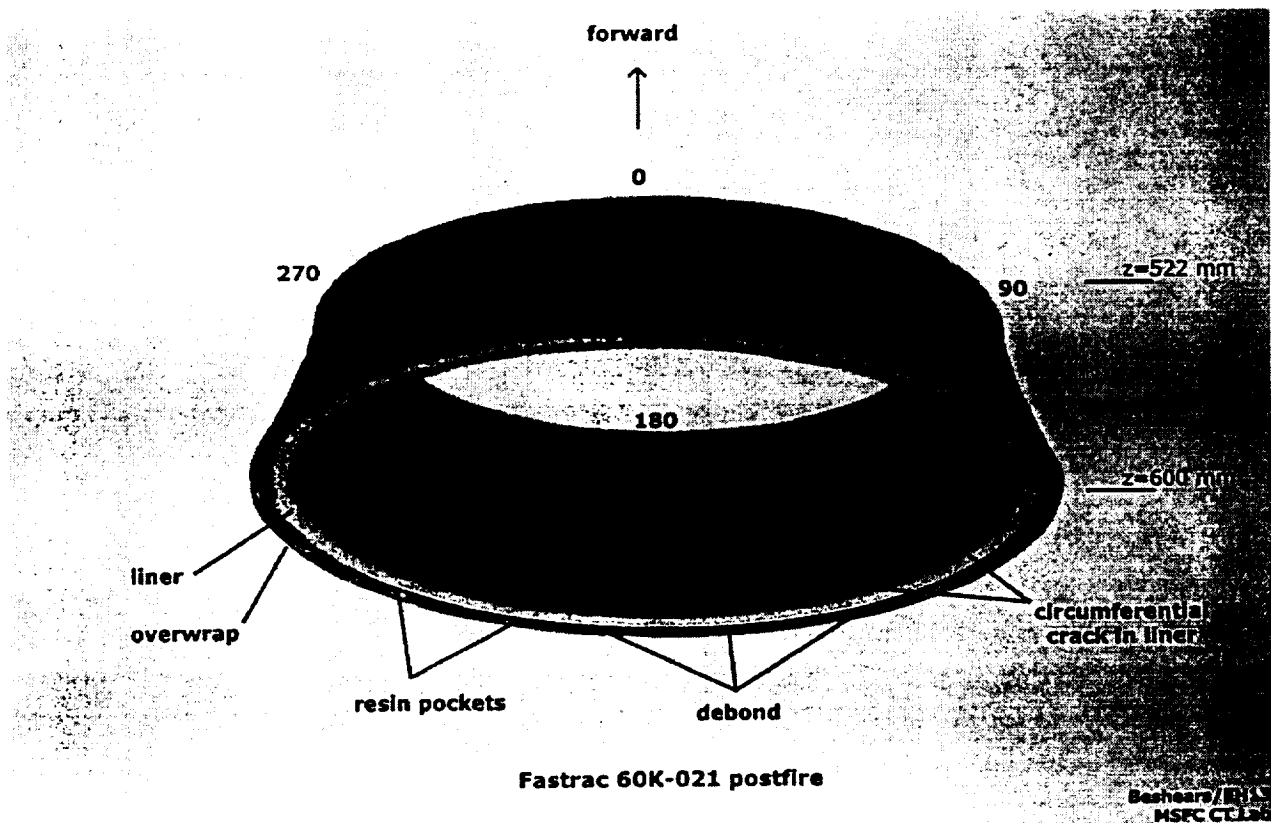
Figure 13. Another view of the 3d reconstruction of 60K-21 postfire, showing the extent of the delamination in the liner. Debonds and winding pattern LDIs are also visible.

As was the case with the crack in 60K-1, the delamination in 60K-21 was not visible on visual inspection even though it was open to the liner i.d. surface, because a heavy layer of charred liner material obscured the opening of the delamination at the surface. Program engineers chose not to fire 60K-21 again based on the results of the CT inspection. A similar finding in the post-fire 60K-17 TCA led to the same decision for that TCA.
